# Advanced Gas Turbine

## Technology Project

### Sixth Semiannual Report

For work performed from 1 July 1982 - 31 December 1982

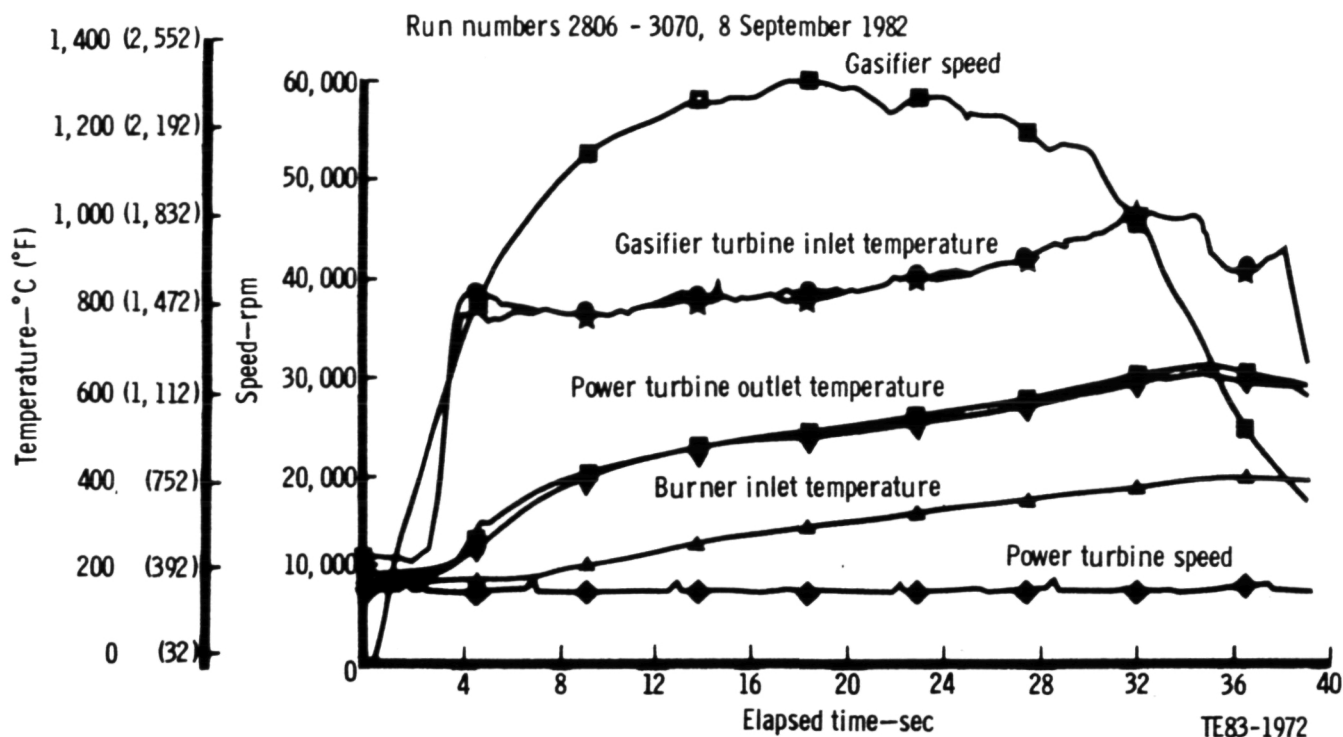
Figure 9. Start transient, BU2.

Typical engine transient response during these start attempts is shown in Figure 9. Temperatures and gasifier speed are shown versus elapsed time. The graph shows light-off peak temperature to be about 815°C (1500°F). The speed rose to about 68% and then decayed. For this run, the control governing speed was set to 70% speed. The turbine inlet temperature (TIT) had not risen above 815°C (1500°F) by the time peak speed was reached, but did rise to about 980°C (1800°F) when speed had decayed to about 52%. Starter shutoff occurred shortly thereafter. It was clear that speed decay occurred even though energy available (TIT) increased. Thus it was concluded that thermal effects and/or mechanical drag caused an increase in the required-to-run TIT beyond what was available. Additional starts were attempted with generally similar results obtained.

A routine borescope examination showed broken turbine vanes, and the engine was removed from the test stand. Disassembly of the engine showed the following:

- all gasifier turbine rotor inducer blade tips were uniformly broken approximately 9.5 mm (0.375 in.) from the outside diameter
- all ceramic vanes in the gasifier and power turbines were damaged
- rub on the rear of the gasifier turbine rotor and its associated backplate had occurred
- rub on the gasifier rotor exducer had occurred, and

- rotor material had adhered to the shroud surface
- light power turbine rotor rub had occurred with very light debris damage to the rotor blades
- regenerator disk was slightly scored

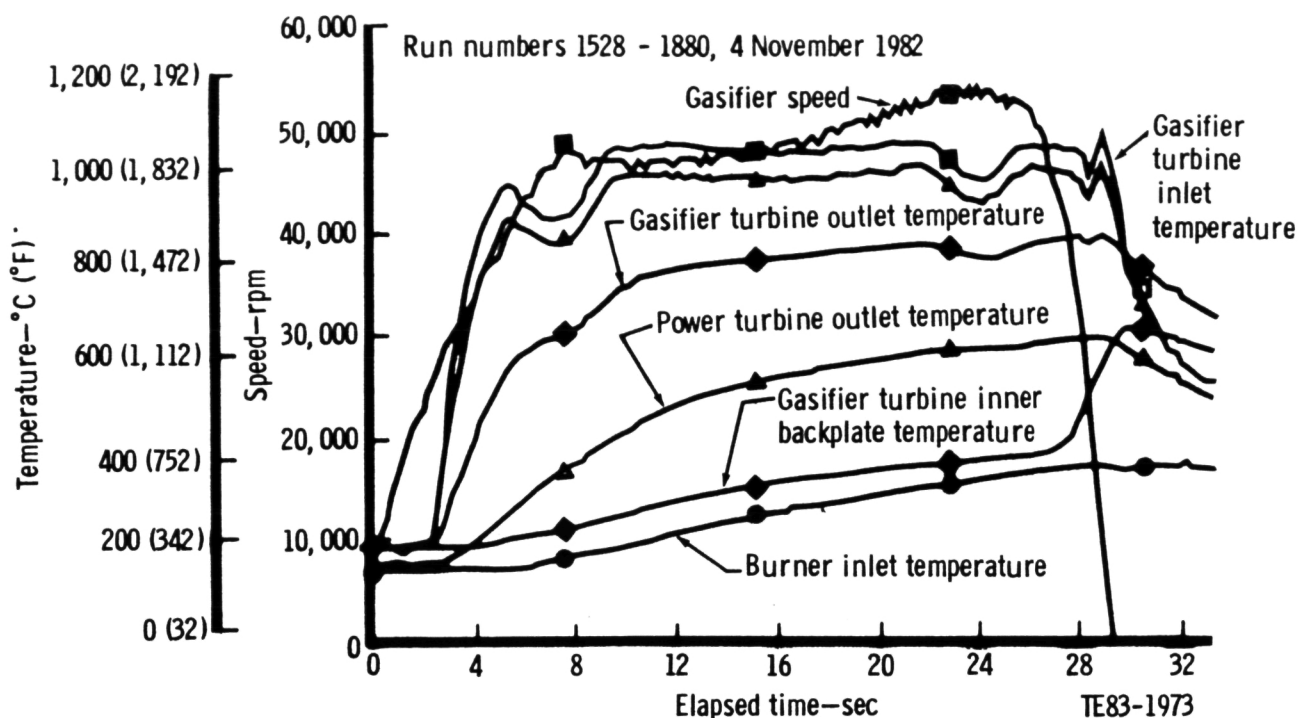
Figure 10. Start transient, BU3.

A plot of engine speed and various temperatures versus time is shown in Figure 10. Starter drop occurred automatically at 53% speed, at about 7.5 sec elapsed time. Light-off TIT peaked at about 980°C (1800°F) and fell back to 870°C (1500°F) at starter drop. After the starter dropped, speed sagged. TIT then increased by automatic control action to achieve the preset governing speed of 60%. This speed was reached at about 22 sec, at which time the control appropriately cut back fuel to prevent overspeeding. Speed started to decay abruptly at about 26 sec. A curve showing the surface temperature of the gasifier turbine inner backplate is also shown in Figure 10. The abrupt increase in temperature at 27 sec indicated the oc-

currence of rub.

Mechanical drag, or rub, has played a major role in the test results. During the test of BU3 (see Figure 10), the temperature response (from rub on the gasifier turbine inner backplate) appeared 3 sec after minimum TIT was recorded. It is reasonable to believe that the drag began at the minimum recorded TIT point and was the cause of the shutdown.

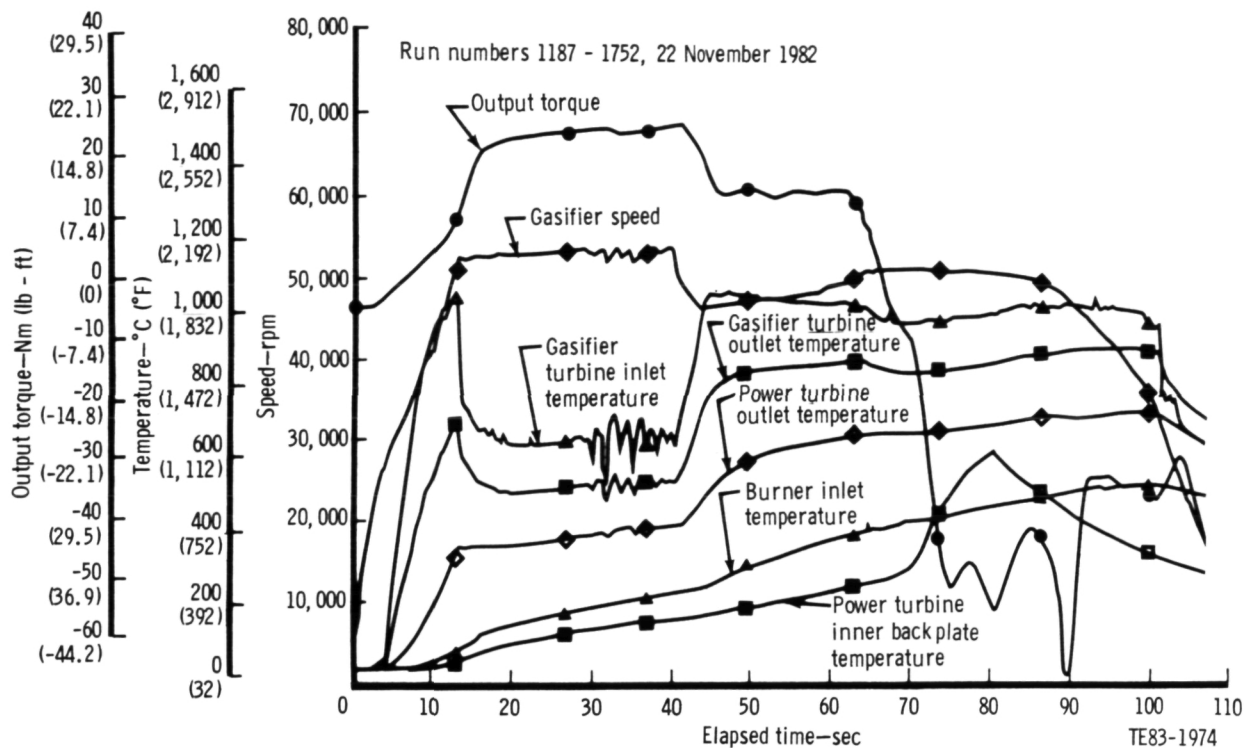
Figure 11. Start transient, BU4.

Disassembly revealed that the power turbine rotor to inner backplate rub had caused the backplate to rotate. This movement damaged a rope seal between the inner and outer backplates. The damage to the rope seal allowed a substantial leakage path from burner inlet pressure to power turbine inlet pressure. A light rub was once again seen at the gasifier turbine exducer. Subsequent performance analysis showed that an assumption of 3.6% leakage from burner inlet cavity into the power turbine correlated with the observed transient data.

A study of the rub pin dimensions in relation to cold dimensions showed that the power turbine inner backplate was moving axially (i.e., not coning) into the turbine. Further transient thermal analysis indicated that the upper backplate, upon which the inner backplate is located, was distorting to allow this interference.

During the test of BU4, the power turbine rub opened a leak path for air to bypass the combustor and gasifier turbine. It is clear from the data recordings of dynamometer torque (see Figure 11) that rub started at about 62 sec, whereas minimum TIT occurred at 70 sec. Seal damage allowing leakage most likely occurred at the time the TIT

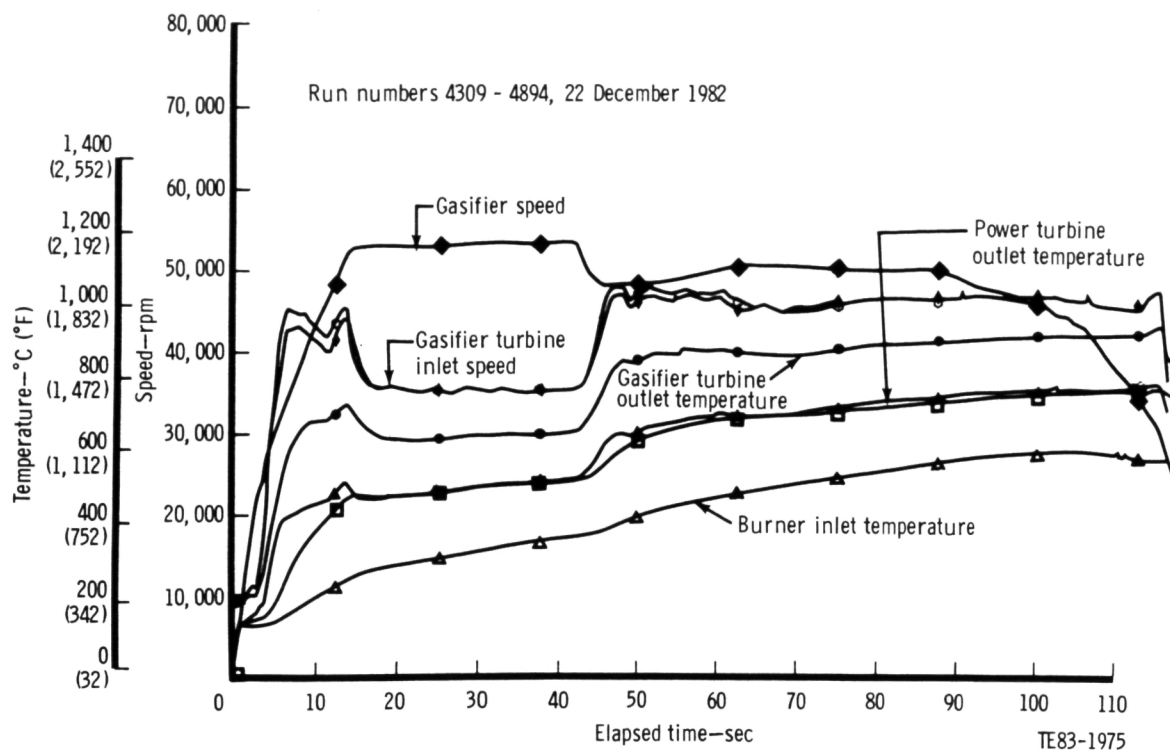
Figure 12. Start transient, BU5.

During the start that followed that of Figure 12, speed decayed rapidly after starter drop. A borescope inspection at that time showed a broken ceramic seal platform at the point adjacent to the power turbine exit, where it forms part of the flow path. The ceramic part is not rigidly connected to the power turbine scroll but is connected by a loose coupling, sealed with piston rings. A post-test analysis showed that the piston ring end gap was not sufficient to accommodate ring thermal expansion at the temperature level achieved on BU5. This allowed the piston ring to expand and overstress the ceramic part.

It is not clear exactly when this failure occurred, other than presumably at temperatures higher than heretofore obtained. Higher flow-path temperatures at the piston ring station did occur at the end of the run shown in Figure 12 and in the subsequent run. A crack that opened during a run would leak burner inlet air to the power turbine exit position. However, no clear evidence of a change in leakage is apparent in the test data.

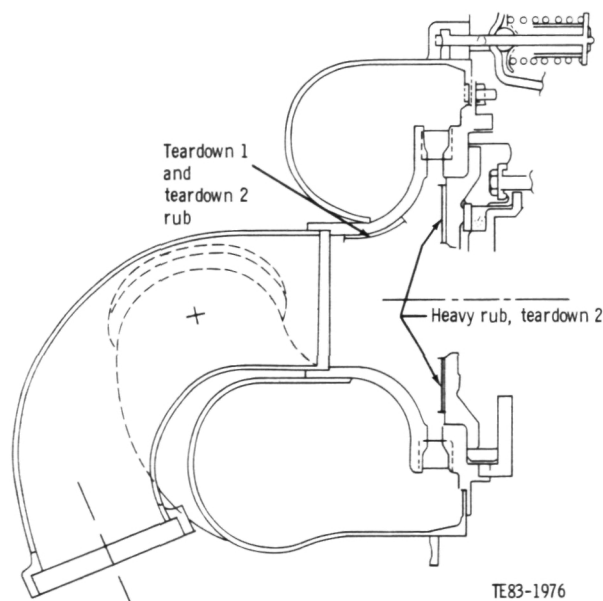
Figure 13. BU2 gasifier turbine rub areas.

A thorough failure analysis concluded that the most likely primary failure was the loss of the gasifier rotor inducer blade tips due to fatigue caused by heavy rub. A positive determination of fatigue was impossible because of impact damage on the blade tip fracture surfaces. The source of heavy rub was determined to be caused by an unseating and the resultant cocking of both scrolls due to air loads exceeding spring retention force. This determination was based on the rub patterns of the various parts, condition of the rub pins, and calculations of the net forces acting on the scrolls. The damage to the ceramic vanes, clearly secondary, was caused by rotor debris.

Teardown inspection of the engine showed indications of light rub on both gasifier and power turbine shrouds and heavy rub on the gasifier turbine inner backplate, as shown in Figure 13. In addition to the rub, approx-

imately 1 mm (0.039 in.) of the gasifier turbine rotor blade tips were missing, and the ceramic vanes in both turbines failed. The failure sequence could not be positively established due to damage of the relevant detail parts. However, high confidence is placed in the theory that the most likely primary failure mode is a gasifier rotor blade tip fatigue failure induced by heavy rub with the shroud and/or backplate. It was further concluded that the ceramic vane failures were secondary and were caused by the impact of the rotor blade tips.

For the third build, configuration changes were made to correct the cause of BU2 failure. As a precautionary measure, all gas-path rub pins were removed. The turbine scroll retaining loads were increased by adding springs and by reducing a static load imposed by the combustor assembly. Metal vanes were used to expedite build, since a second proof-tested set of ceramic values was not available.

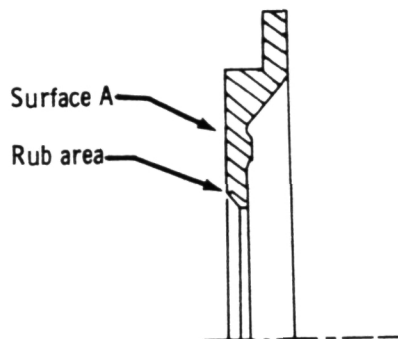
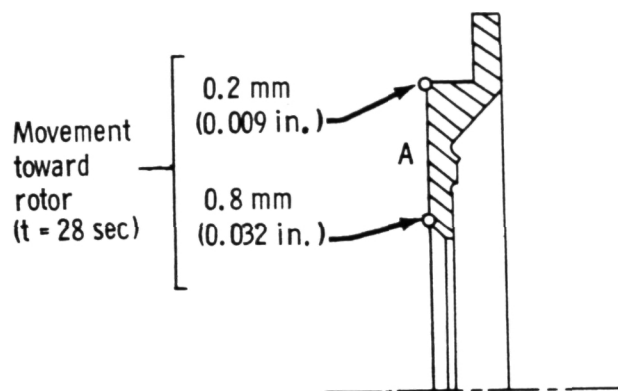
Figure 14. Gasifier turbine inner backplate—rub area.

celerated satisfactorily to idle speed, self sustained, and stabilized for a short period. Then speed decayed, and the run was terminated. There was no gasifier inner backplate temperature indication of rub and no indication of backplate rub on teardown. In fact, rub pin measurement after testing confirmed that the gasifier backplate coned the predicted amount and also translated axially. The cause of run termination was found to be rub of the power turbine backplate (see Section V).

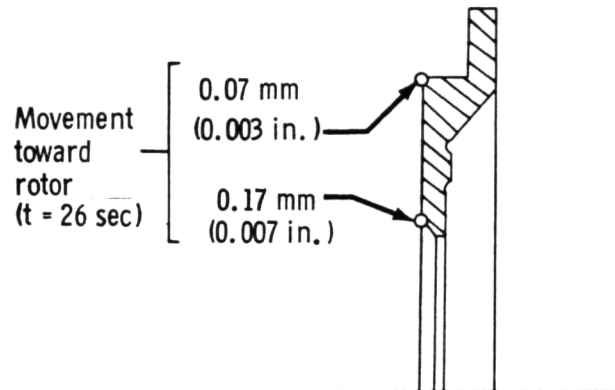
Figure 18. Power turbine inner backplate—transient deflection.

The power turbine system showed rub between the rotor and inner backplate inside diameter similar to the gasifier inner backplate rub during BU3. During running, the power turbine backplate thermocouples had indicated that rub had occurred. On teardown inspection, the rub pin measurements indicated that the power turbine backplate translated axially (not by coning, as previously experienced on the gasifier backplate). The power turbine rub did not directly cause the gasifier rotor speed decay, since on this build the two rotors were not connected mechanically. Teardown inspection revealed, however, that the power turbine inner backplate ceramic rope seal was out of its groove and wedged between the inner and outer backplate. This resulted in an air leak into the power turbine scroll.

Since the power turbine inner backplate analysis done prior to this test indicated a very minimal amount of coning (0.1 mm [0.004 in.]), which did not explain the rub, and the rub pin measurements indicated the backplate translated, the transient heat transfer and deflection analysis was extended to the power turbine scroll assembly. The results showed coning of the outer backplate, which caused the inner backplate to translate, as shown in Figure 19. The sum of deflection due to coning, translation due to outer backplate coning, and thermal growth of support structure was sufficient to use up the build clearance

and cause rub.

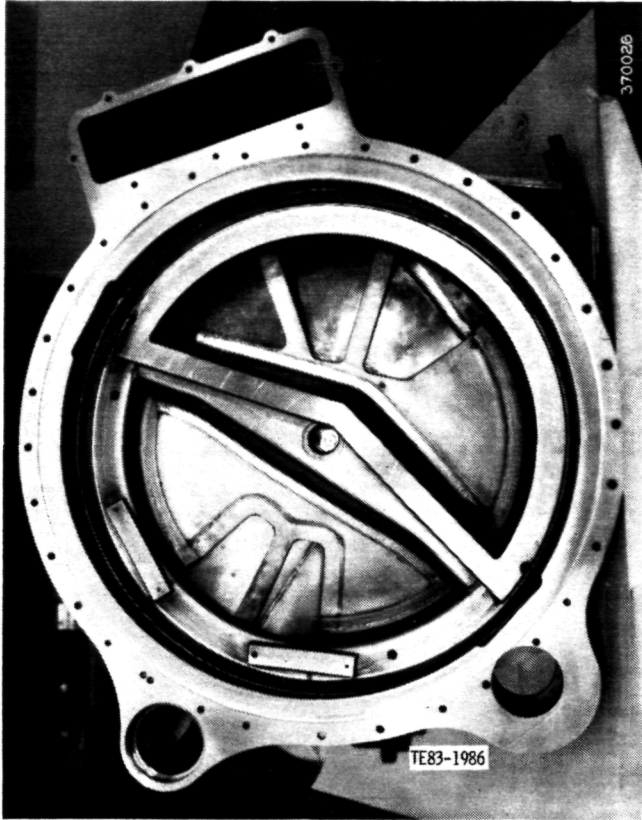
Figure 24. Regenerator cover before rework.

Testing of the initial engine configuration resulted in a calculated degradation in regenerator effectiveness of 10.6%, due primarily to poor distribution characteristics of the air side. A series of eight modifications were tested, the first two of which were reported in the preceding semi-annual report (Ref 1). The second of these two modifications successfully improved the disk effectiveness, but at the expense of increasing the pressure drop from 0.5% to 1.5% (see Figure 21). The addition of the side air inlet at the disk perimeter (Mod II, Figure 21) was then combined with the original flow path, and various flow splits (Mods III-VIII) were tested to tailor a configuration meeting requirements of matching both distribution and low-pressure drop.

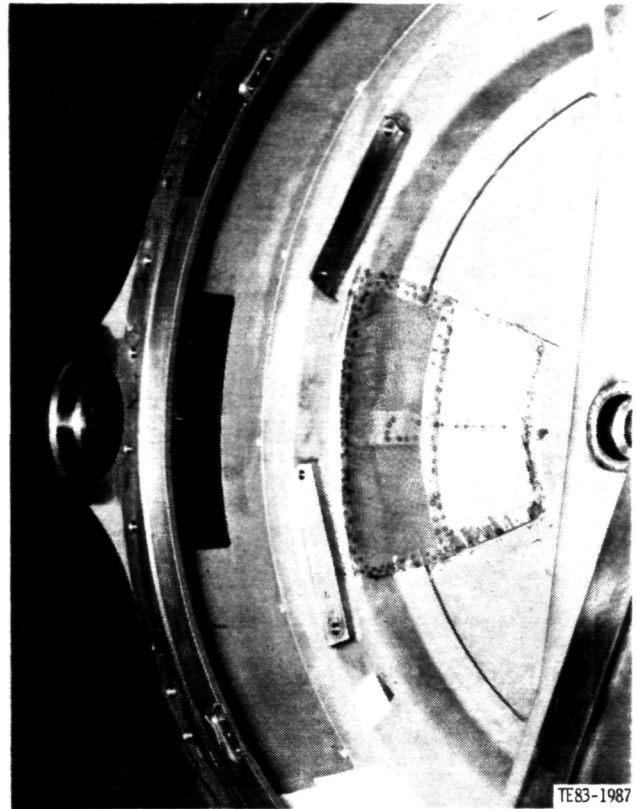
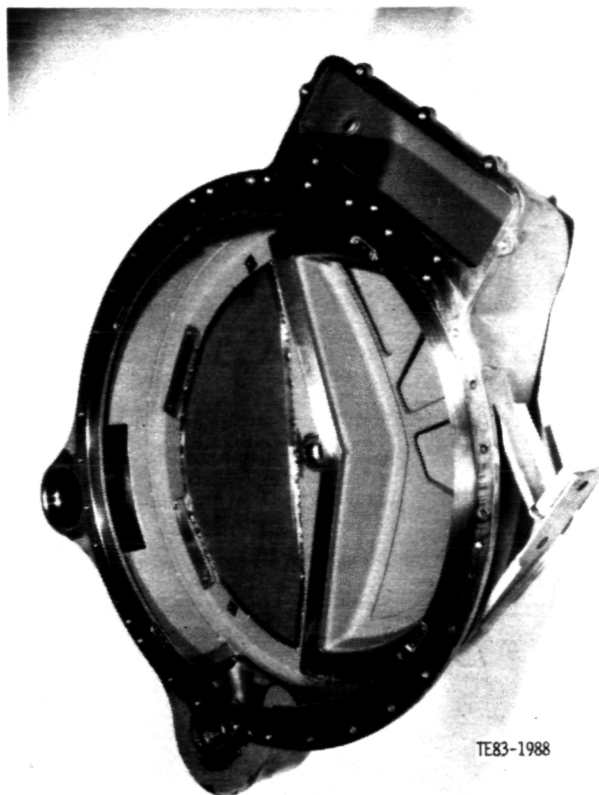
Figure 25. Rework of regenerator cover showing additional air inlet and trip screen cover of original inlet windows.

Figure 26. Completed rework of regenerator cover to improve air side flow distribution.

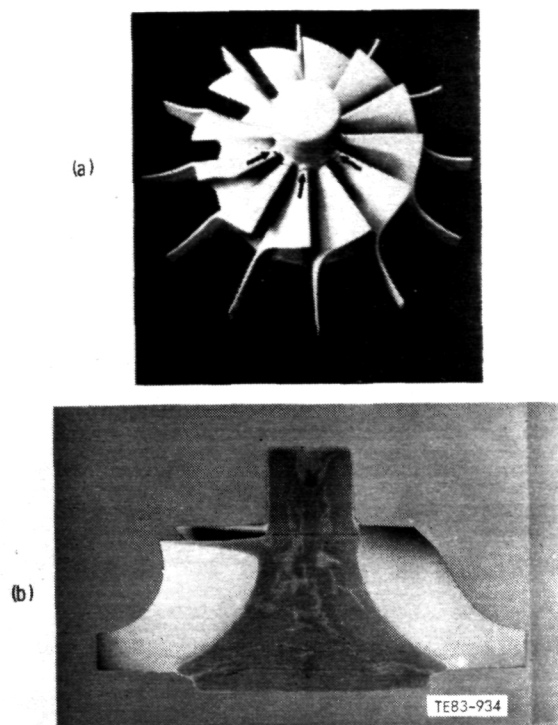
Figure 38. Typical flaws observed in sintered  $\text{Si}_3\text{N}_4$  rotors: (a) surface cracking and (b) internal laminations.

milled powder also greatly reduced the internal cracking. This was attributed to the needle-shaped unprocessed powder minimizing particle rearrangement, thereby reducing differential shrinkage inside the part.
